**SHEAR TESTS CONDUCTED ON NOVABRIK BRICKS
ATTACHED TO A CONCRETE BLOCK WALL**

CRIQ File 670-PE20888

Technical Report

MONTREAL, NOVEMBER 3, 1997

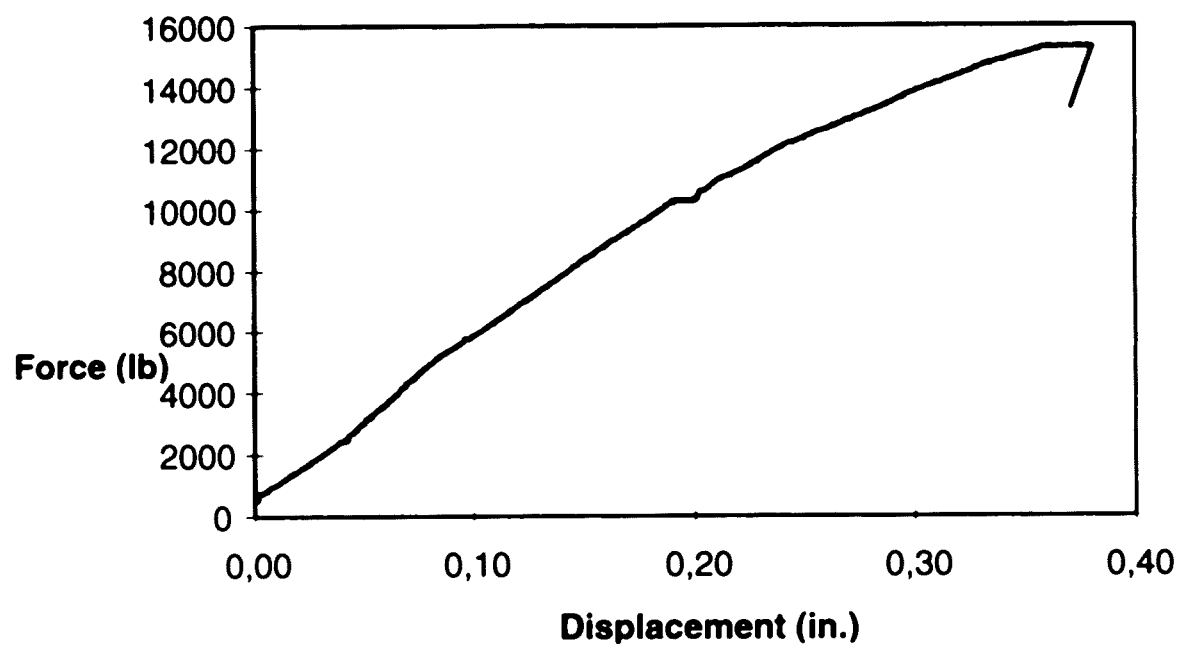
The displacement and force results are presented in Table 1 and graphic form in Fig. 5. The recorded displacement is very weak (0.04 of an inch) and it remained stable during the pause at 2,450 pounds. The maximum value recorded at a force of 15,300 pounds is 0.38 of an inch. The resistance of this wall is quite significant.

Figure B5. Vertical shearing load according to displacement. Sample E007542 with steel furring. Test no. 1.

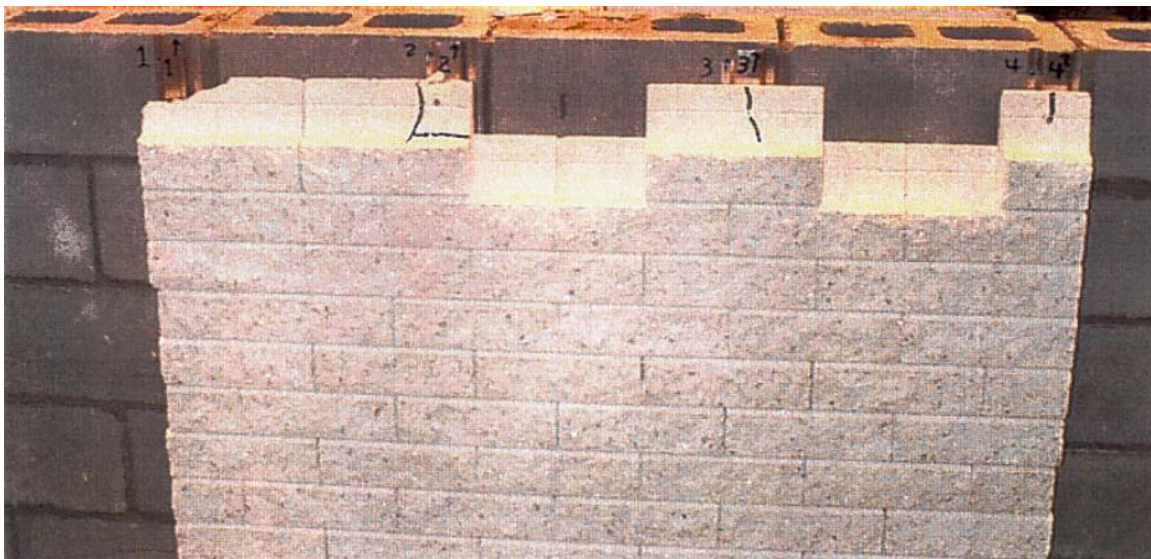
The bricks were unscrewed the morning following the test. The top of the wall after the bricks forming the last course were removed is shown in Figure 6. No rupture was noticed in the unscrewed bricks. Three screws fastening the brick to the furrings and the concrete block broke, and one of these inside of the brick. It's possible that these three screws had been ruptured during installment. The other screws fastening the bricks bent only a couple of degrees at the junction of screw and furring. Many screwed bricks were ruptured or cracked but the range of damage was more significant at the top rather than at the bottom of the wall. Likewise, the screws were less bent at the bottom of the wall than at the top and the enlargement of the screw holes in the furrings was more significant at the top. No rupture of screw or brick was noticed in the lower row where all the bricks were fastened with two screws.

The results of the force on displacement and the observations show that the support offered by this system is excellent. The ruptures were much more significant at the top of the wall than at the bottom, which indicates that a large part of the force was transmitted to the concrete block wall by the screws. The force was only partially transmitted to the bottom and the last course of bricks was only slightly disturbed by this load case. The furrings and the damaged screws have been sent to the client for closer analysis.

**Figure B6. Top of brick wall with steel furrings after testing.
The top row has been removed.**

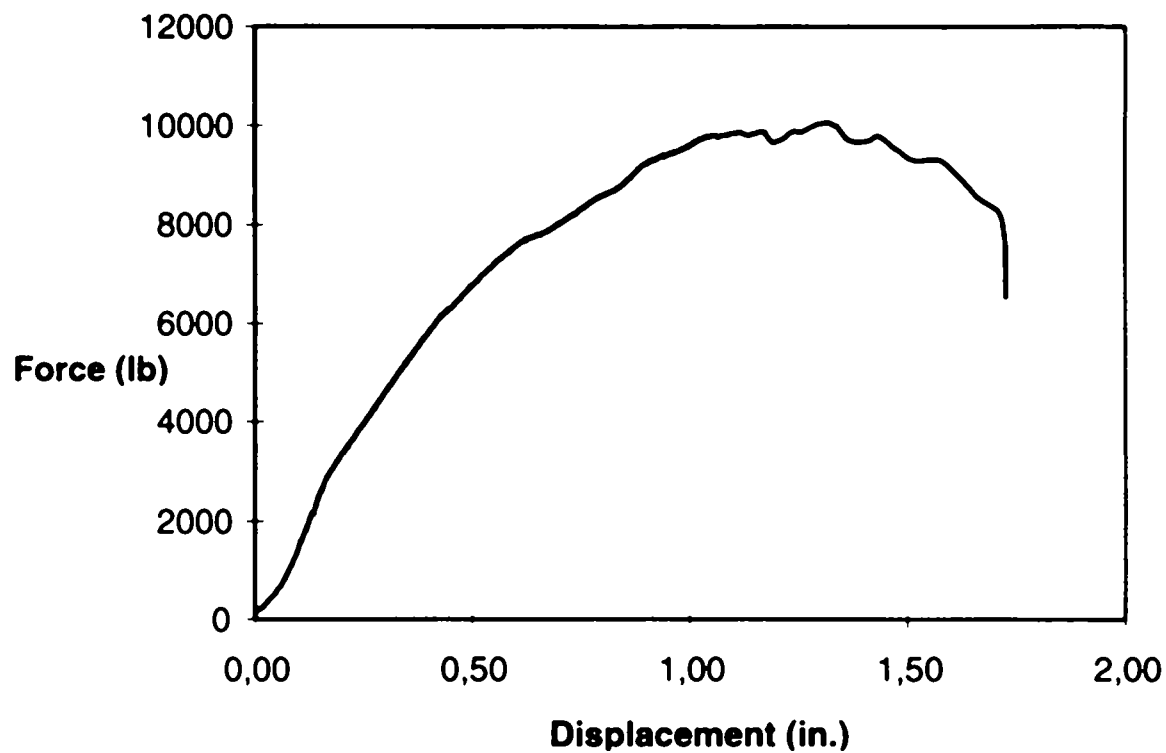
The force applied as displacement is presented in graphic form by Figure 7. We see that the force reached a peak of about 10,000 pounds and that it decreased afterwards, while the displacement continued to increase. This indicates that the wall's maximum capacity was reached during this test. However, because of the method of control of the force during the test, the peak and the decrease of the force occurred in only a few seconds while the increase of the force from 0 to 10,000 pounds lasted about 5 minutes.

Figure B7. Vertical shearing load according to displacement. Sample E007542 with wood furrings. Test no. 2.

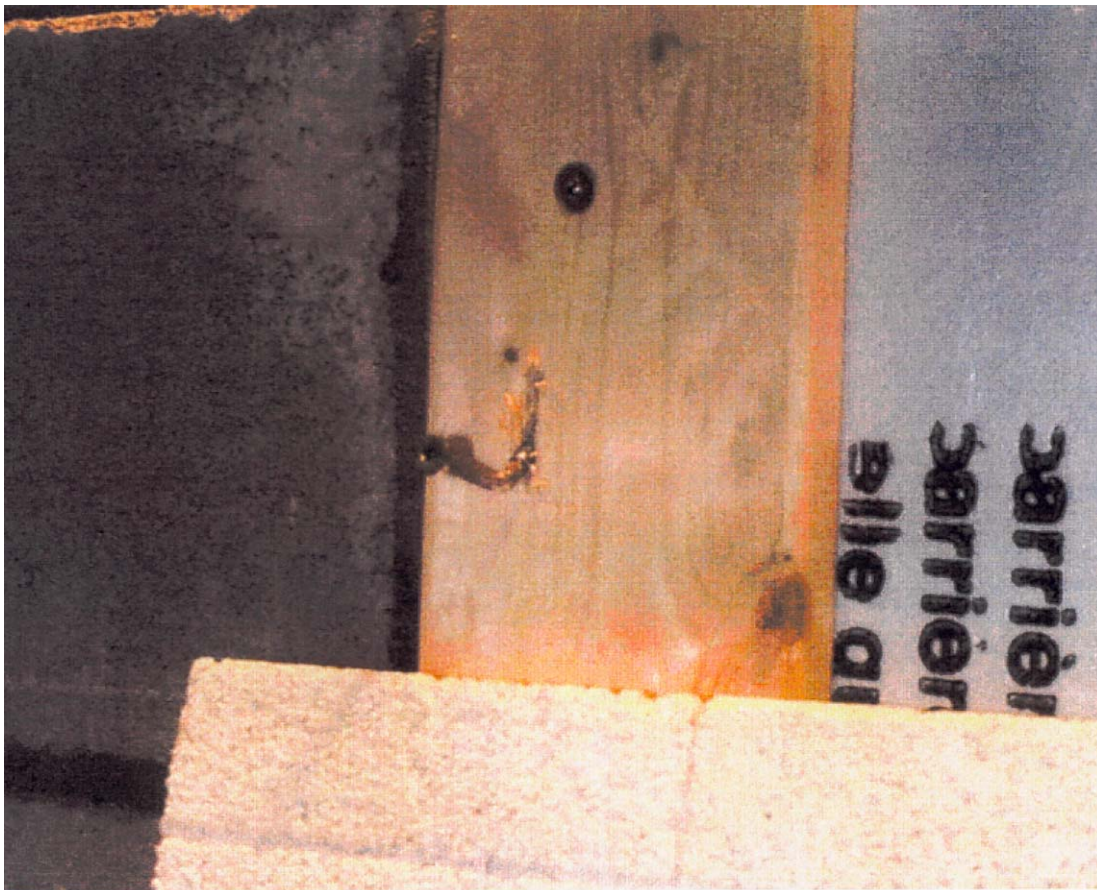
After the test, the materials forming the wall were positioned in a shingle. The concrete wall obviously remained sturdy, the insulation was slightly weakened, the wooden furrings had sunk approximately 1 inch compared to the concrete block wall and the bricks were positioned a little lower.

The wall was dismantled and some observations were made. In all the unscrewed courses, the bricks were intact except for one that was most likely broken under the impact when the brick above was ruptured. In the courses that were screwed, it turns out that a little more than half of the screws were broken and that the other screws had been bent. They were bent about 75° at the top of the wall (see fig. 8), the angle becoming weaker and weaker further down towards the bottom of the wall. The bricks were broken when the screws holding them had bent while the majority of bricks remained intact in the places where the screws were broken. Therefore, the resistance of the bricks is about the same as the resistance of the screws.

Figure B8. Brick wall with wood furrings after testing.

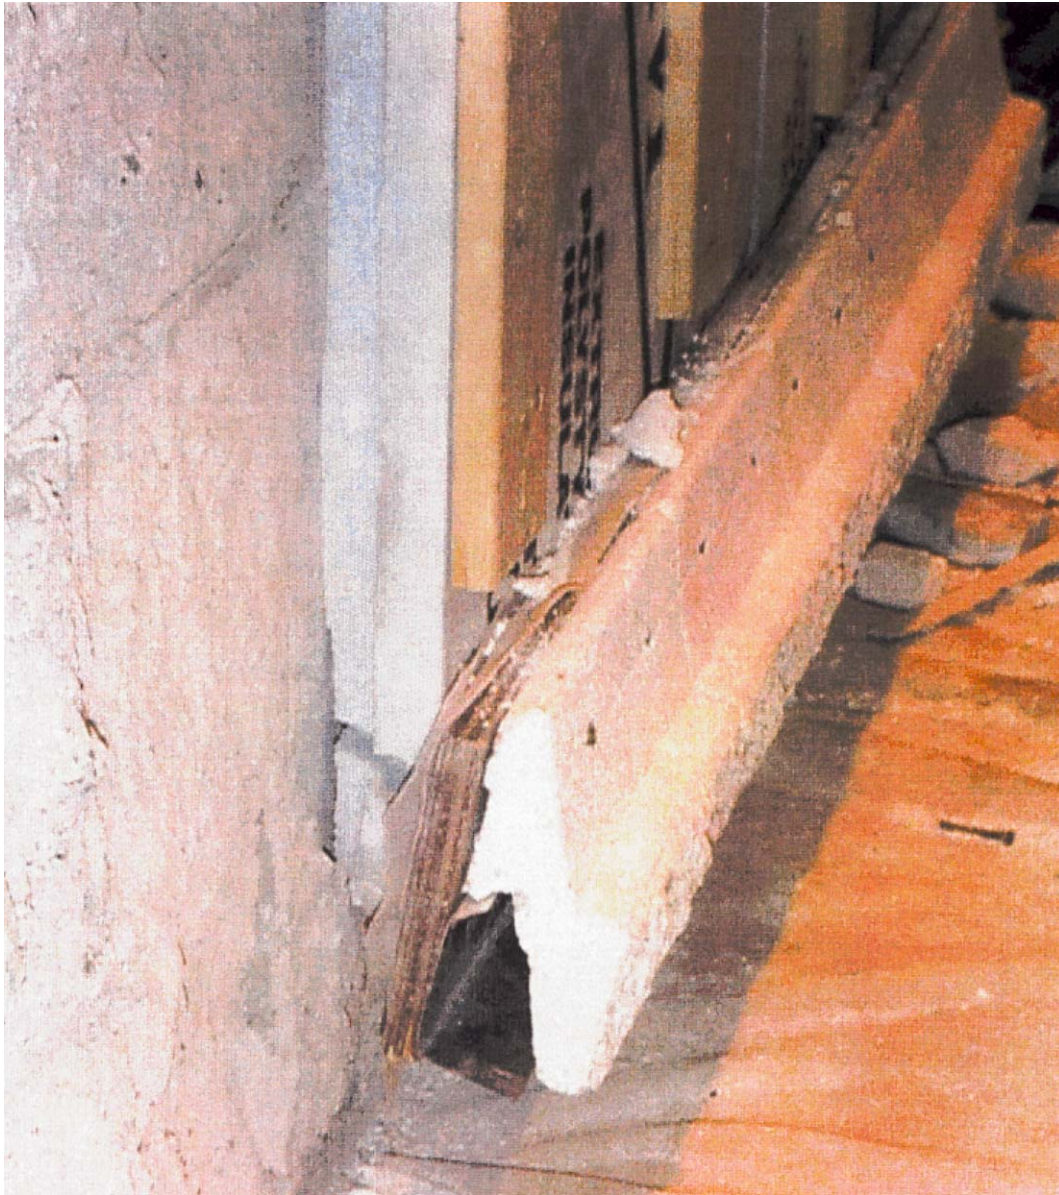
At the bottom course, where all the bricks were fastened with 2 screws, the screws and bricks remained intact after the test. However, the insulation was broken behind the horizontal furrings and the furring-concrete block screws were either bent or broken (see Figure 9). A few had been fastened to the mortar instead of the concrete, which may have weakened the resistance of the furring concrete block device.

With the exception of the lower course, the screws used to fasten the furrings (and the insulation) to the concrete block were intact. However, there was an enlargement of the screw holes in the wood furrings, which explains the weakening of the furrings with respect to the concrete-block wall.

Figure B9. The foot of brick wall with wood furrings after testing.
