June 28, 2001

Engineering Report 21117

Uniform Load Testing
E. Dillon & Company
Nova Brik

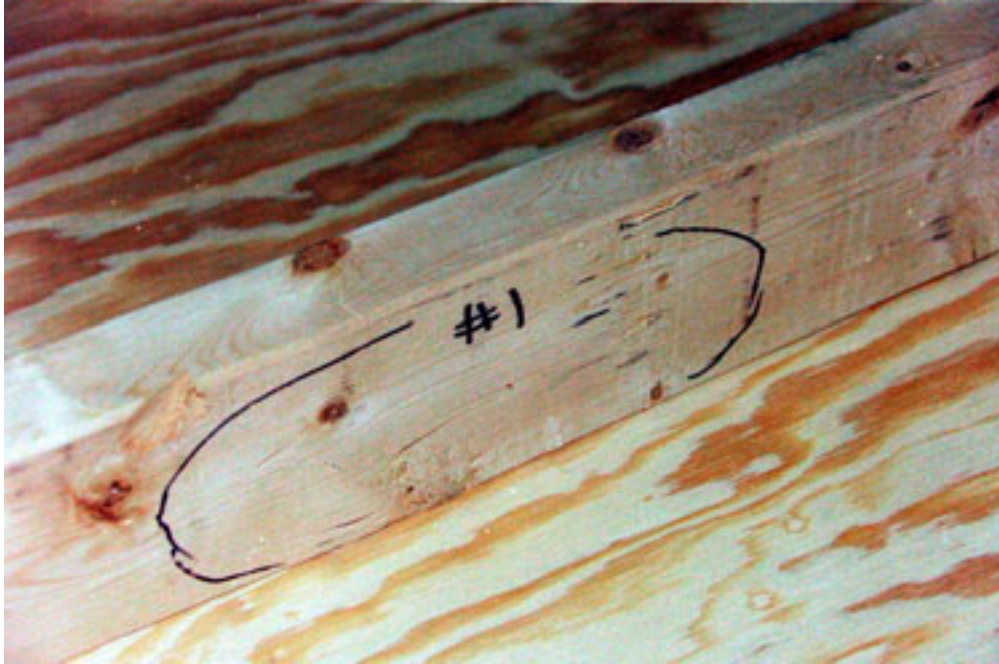
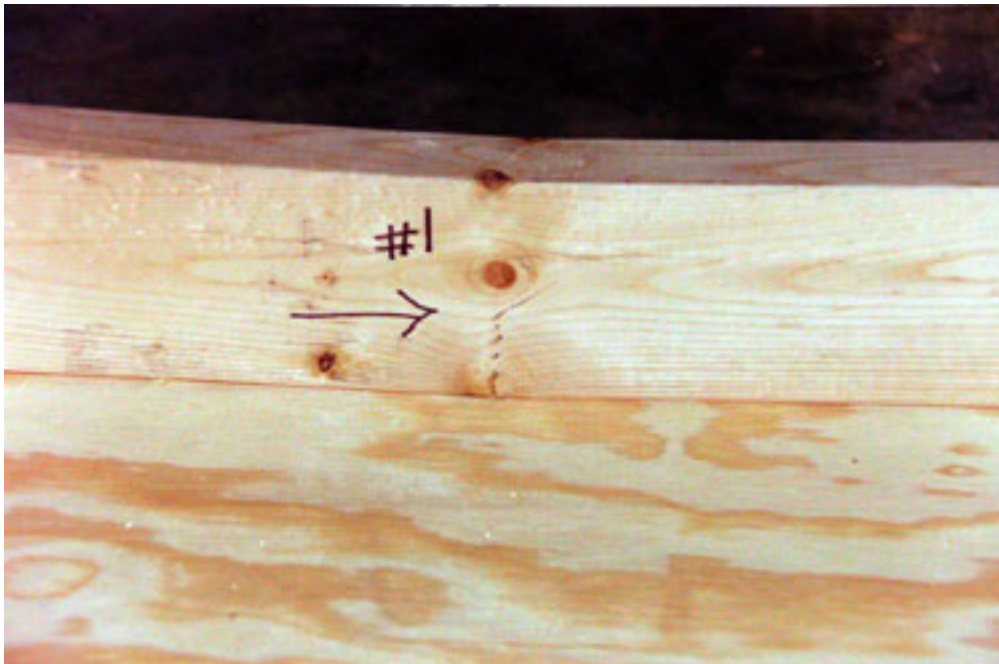
The average ultimate negative load obtained by specimens 1 through 3 was 266 PSF (51 inches H₂O). At this load, the 2 x 4 studs of the wooden support frame failed along the assembly's mid-span, causing loud popping and cracking noises and noticeable deflection of the brick veneer. All three specimens exhibited similar modes of failure (Photographs 19 through 25). Post-failure examination indicated that the wooden studs had cracked in some areas and crushed in others. Average load and deflection data at the wall mid-span are represented in the table, below, and the graph at the end of this report:

PHOTOGRAPH 19
SPECIMEN 1 FAILURE OF 2 x 4 STUD

PHOTOGRAPH 20
SPECIMEN 1 FAILURE OF 2 x 4 STUD

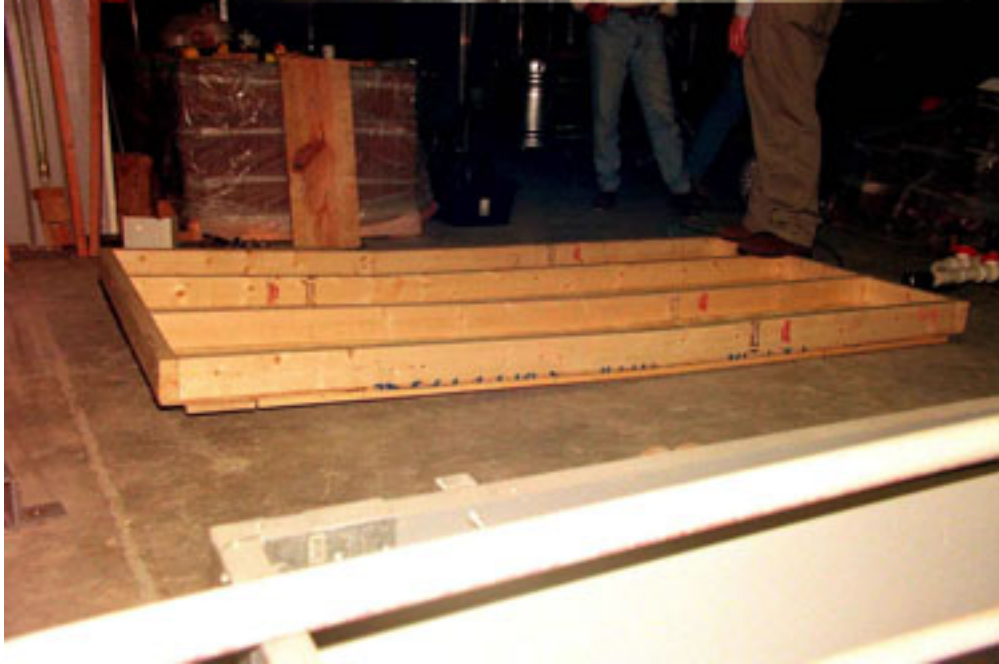
PHOTOGRAPH 21
PANEL 1 BOWING AFTER FAILURE OF STUDS

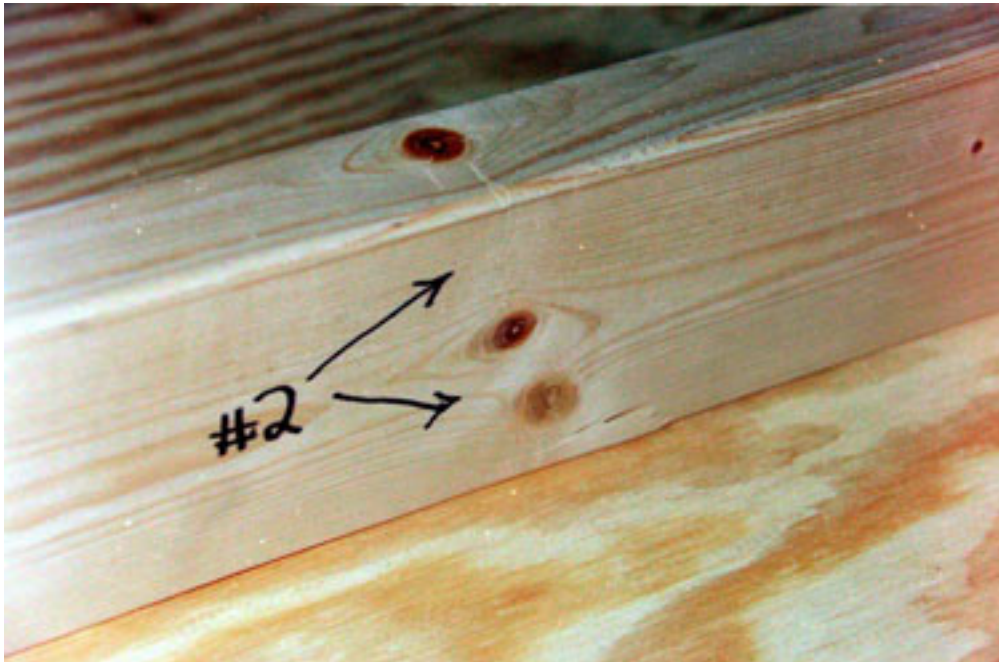
PHOTOGRAPH 22
SPECIMEN 2 FAILURE OF 2 x 4 STUD

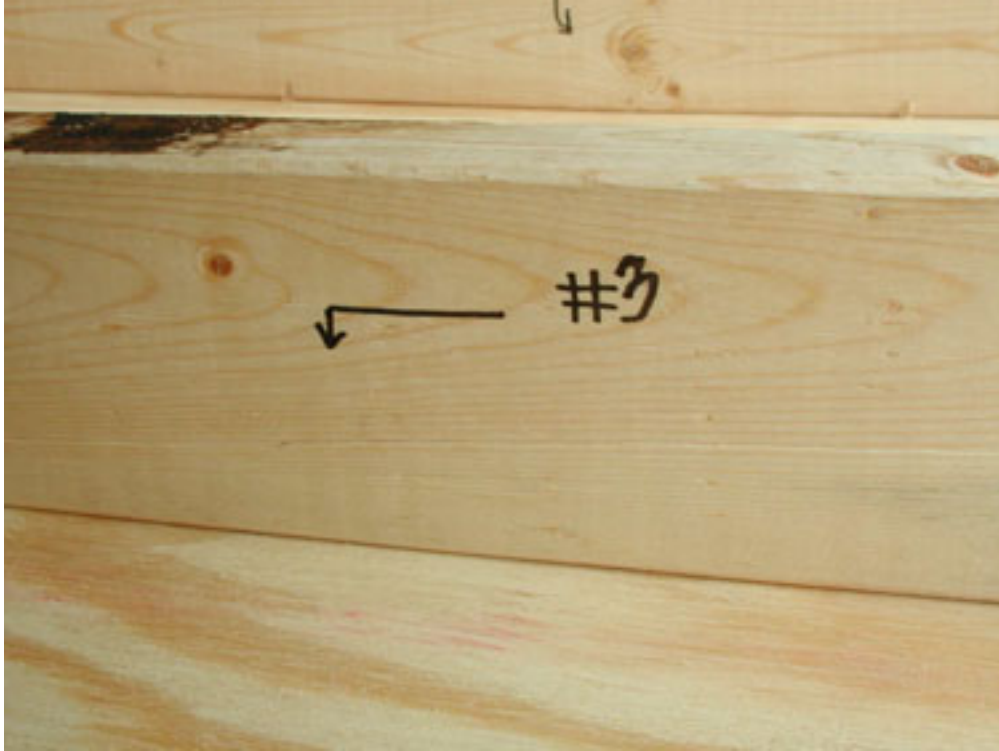
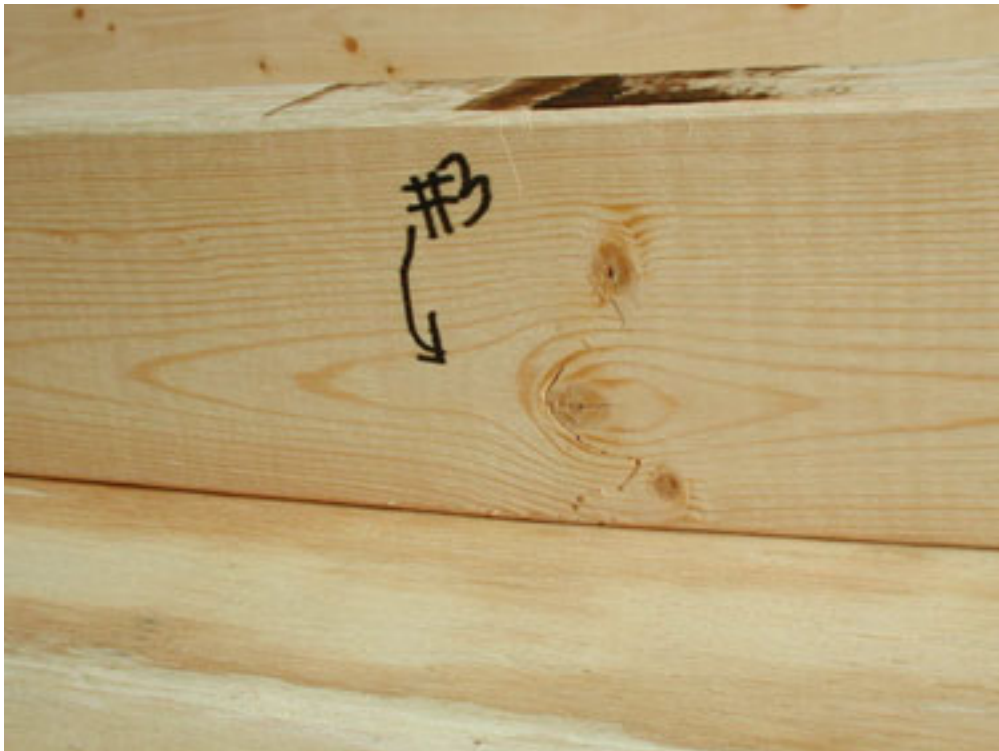
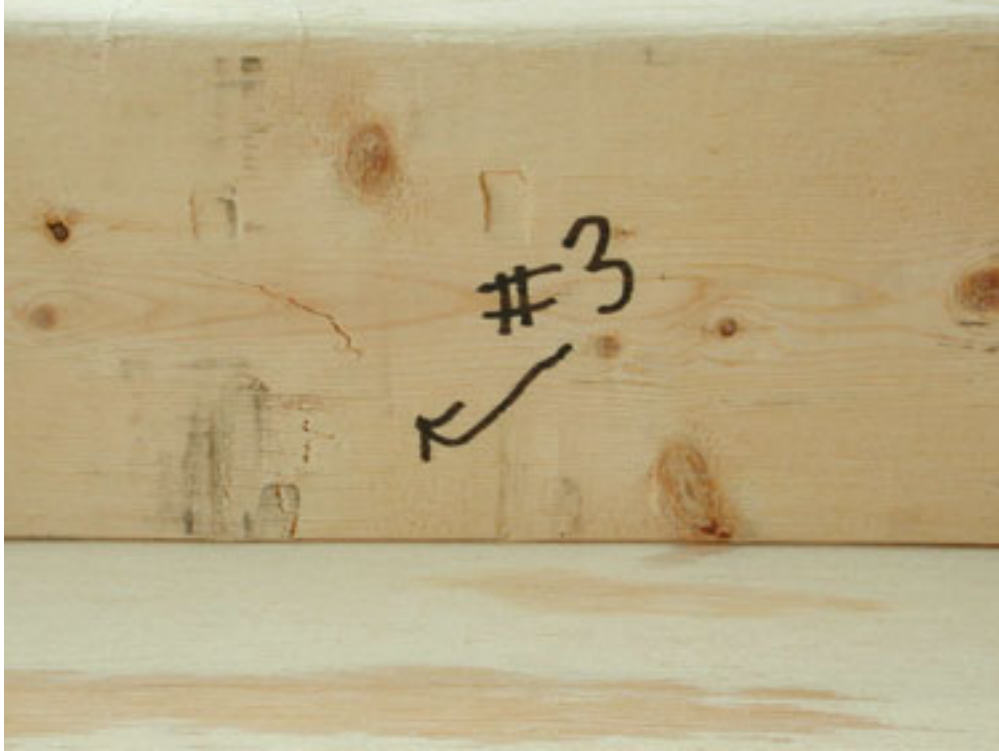
PHOTOGRAPH 23
SPECIMEN 3 FAILURE OF 2 x 4 STUD

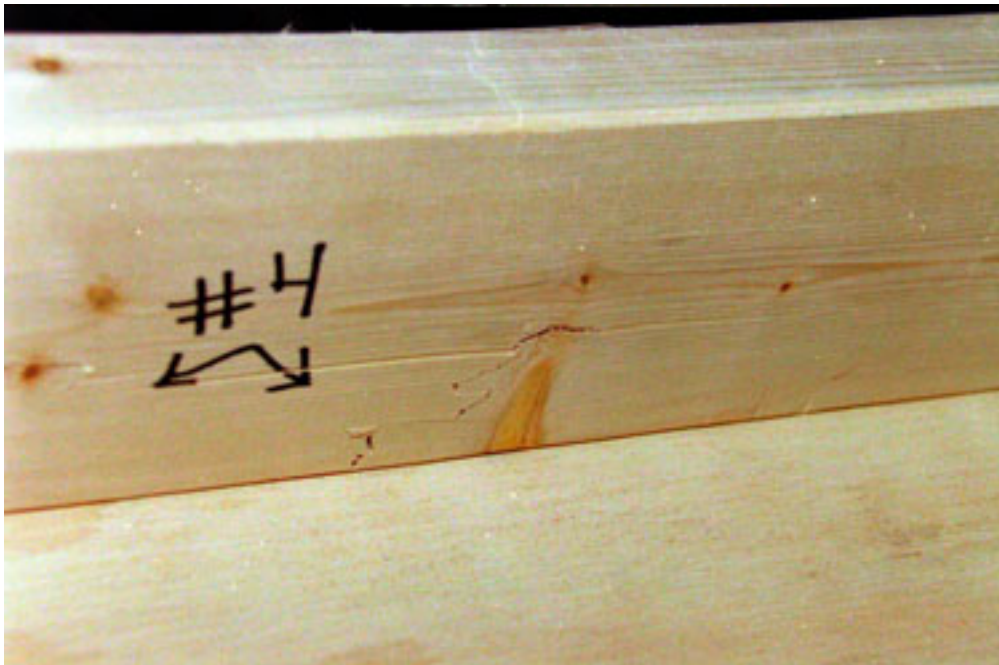
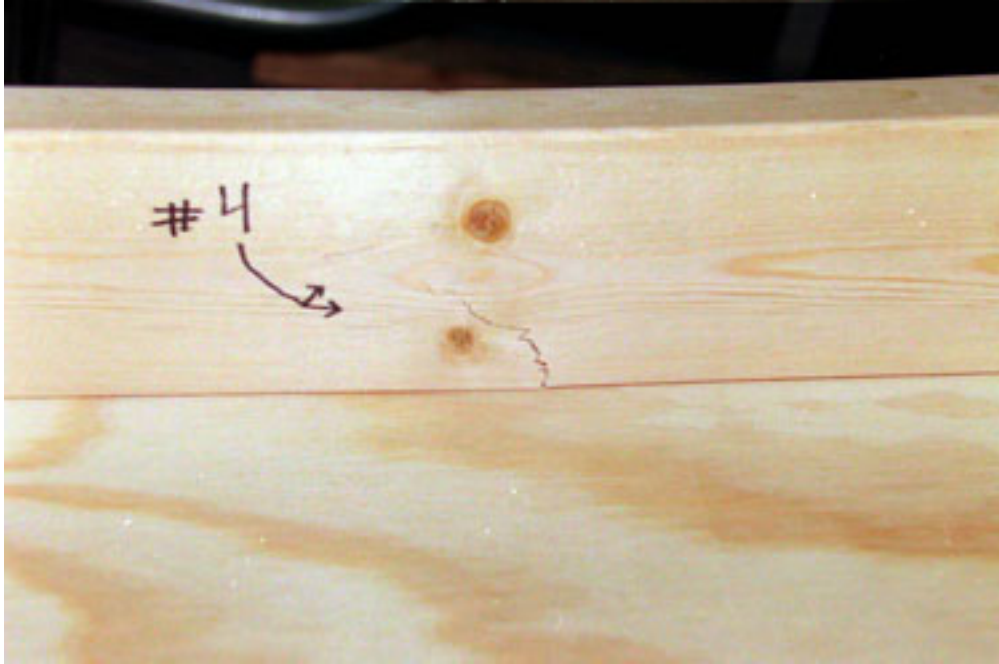
The average ultimate negative load obtained by specimens 4 through 6 was 260 PSF (50 inches H₂O). At this load, the 2 x 4 studs of the wooden support frame failed along the assembly's mid-span, causing loud popping and cracking noises and noticeable deflection of the brick veneer. All three specimens exhibited similar modes of failure (Photographs 26 through 32). Post-failure examination indicated that the wooden studs had cracked in some areas and crushed in others. Specimen 5 also had several partial courses of brick separate and fall away from the upper portion of the assembly. Post-failure examination indicated that several screws had pulled out of the 2 x 4 studs and released the attached brick. These bricks caused other unattached bricks to fall as well.

PHOTOGRAPH 26
SPECIMEN 4 FAILURE OF 2 x 4 STUD

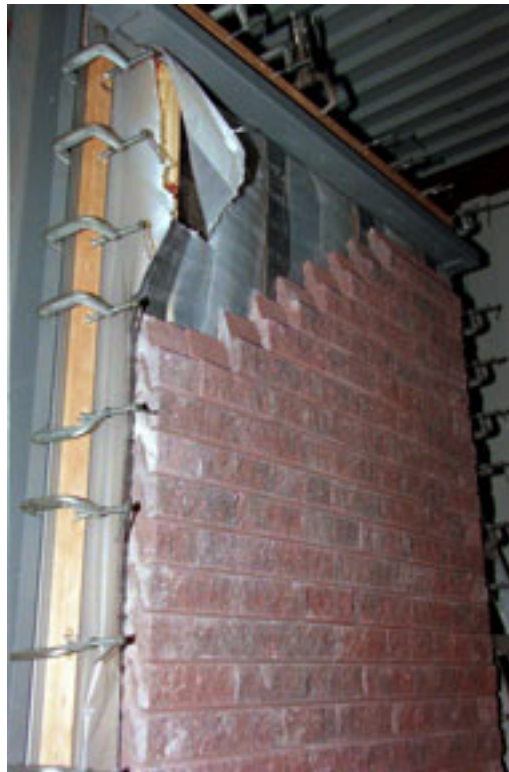
PHOTOGRAPH 28
**BRICKS SEPARATED FROM PANEL AT
FAILURE OF SPECIMEN 5**

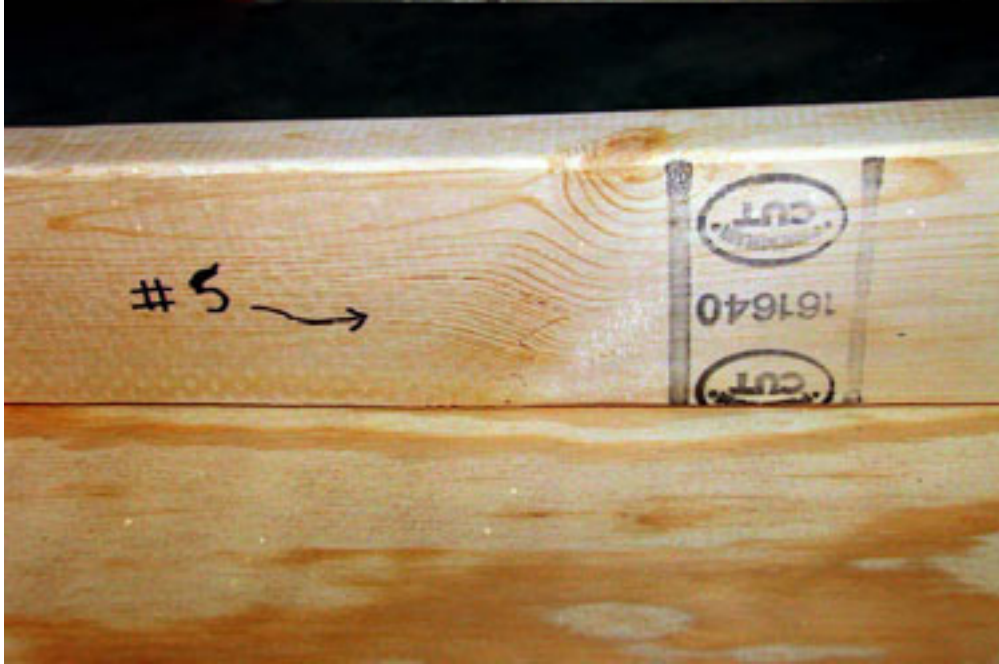
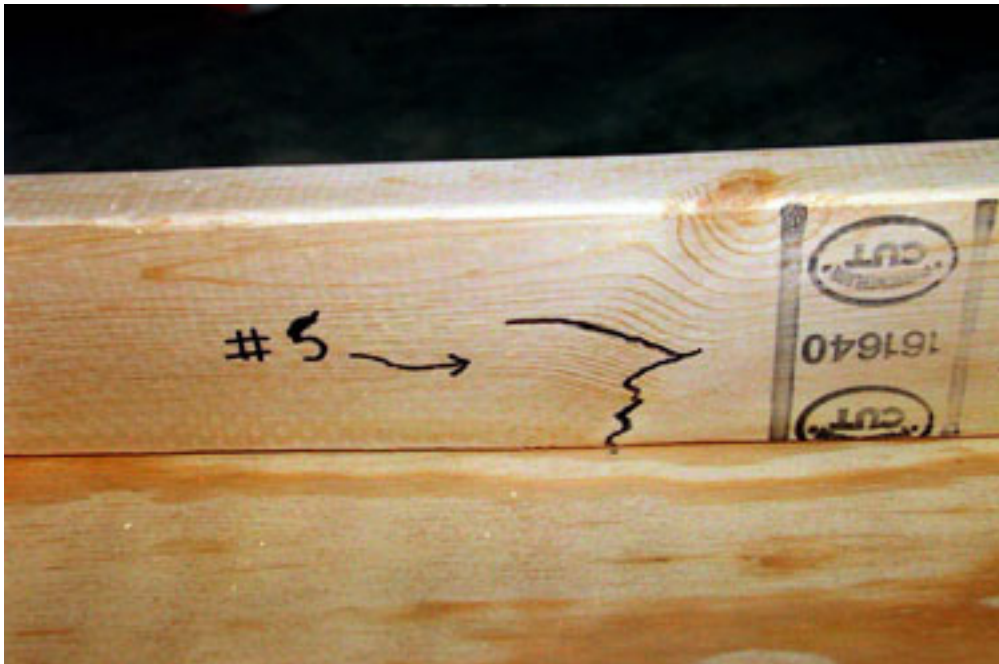
PHOTOGRAPH 29
SPECIMEN 5 FAILURE OF 2 x 4 STUD

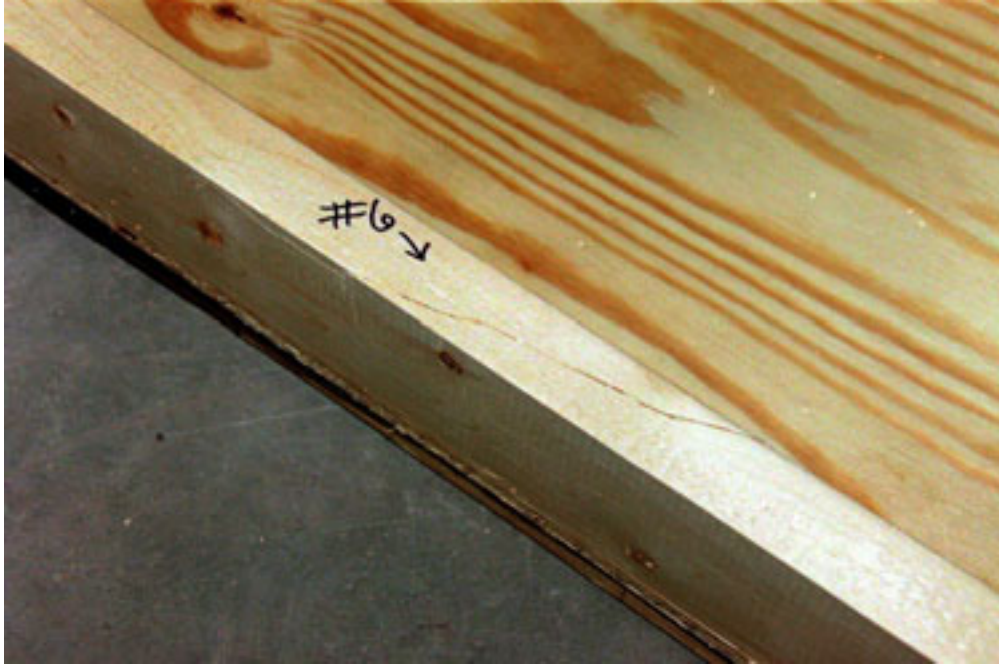
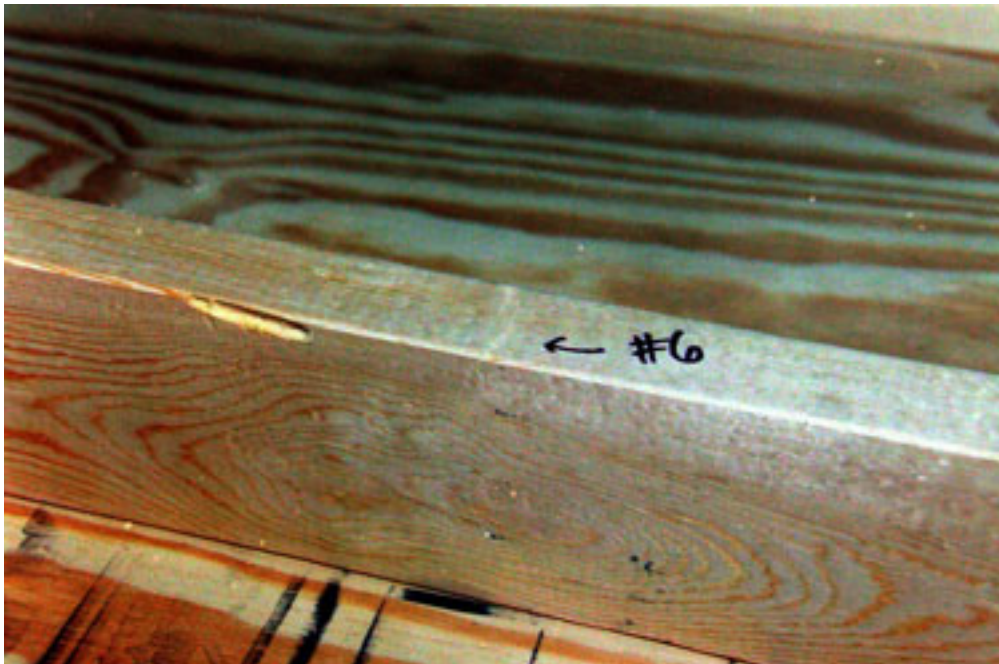
PHOTOGRAPH 31
SPECIMEN 6 FAILURE AT 2 x 4 STUD
