**SHEAR TESTS CONDUCTED ON NOVABRIK BRICKS
ATTACHED TO A CONCRETE BLOCK WALL**

CRIQ File 670-PE20888

Technical Report

MONTREAL, NOVEMBER 3, 1997

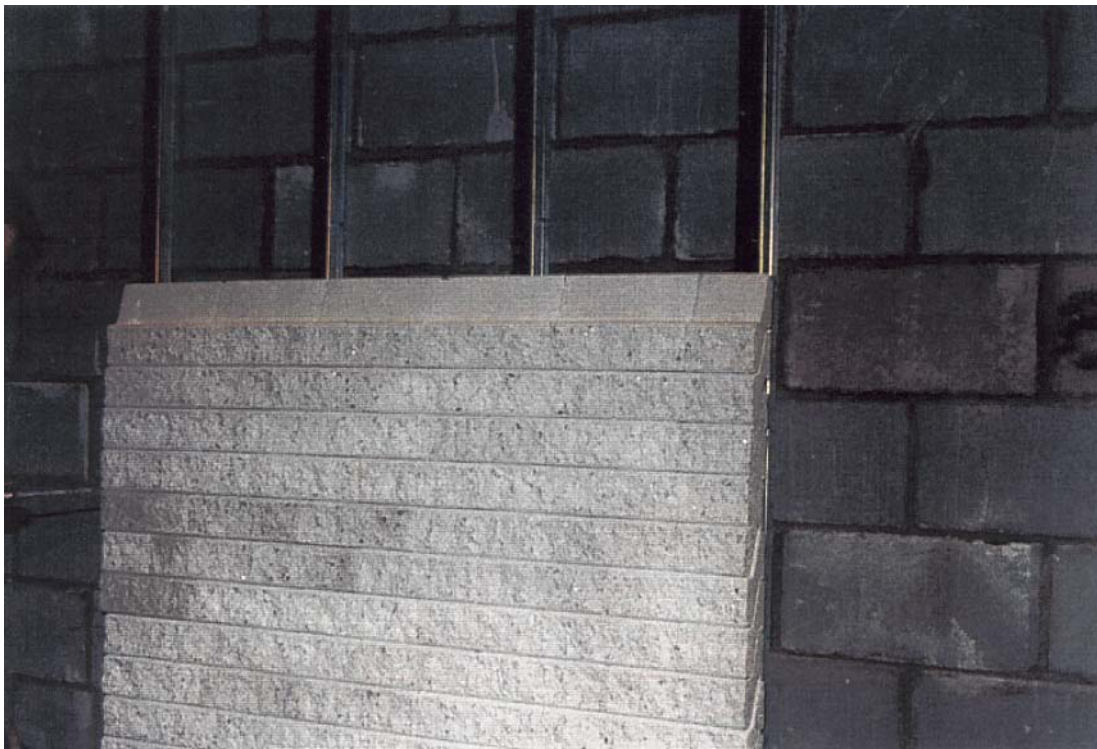
The brick wall with metal furrings offers excellent support. The shear force test on the wall shows that a force of more than 15,000 pounds caused certain ruptures to the brick interlock system. The displacement of the brick wall was less than 0.4 inches. The screws were slightly bent and the screw holes in the furrings had enlarged. Only a few screws had been broken. However, the majority of bricks held by screws were either cracked or broken. The screws were more bent at the top of the wall than at the bottom, which indicates that there was an effective transfer of force to the concrete block wall by the screws. The displacement of the wall by a force 2.5 times that of the load capacity was very weak.

Figure B1. Assemblage of a brick wall with steel furrings.

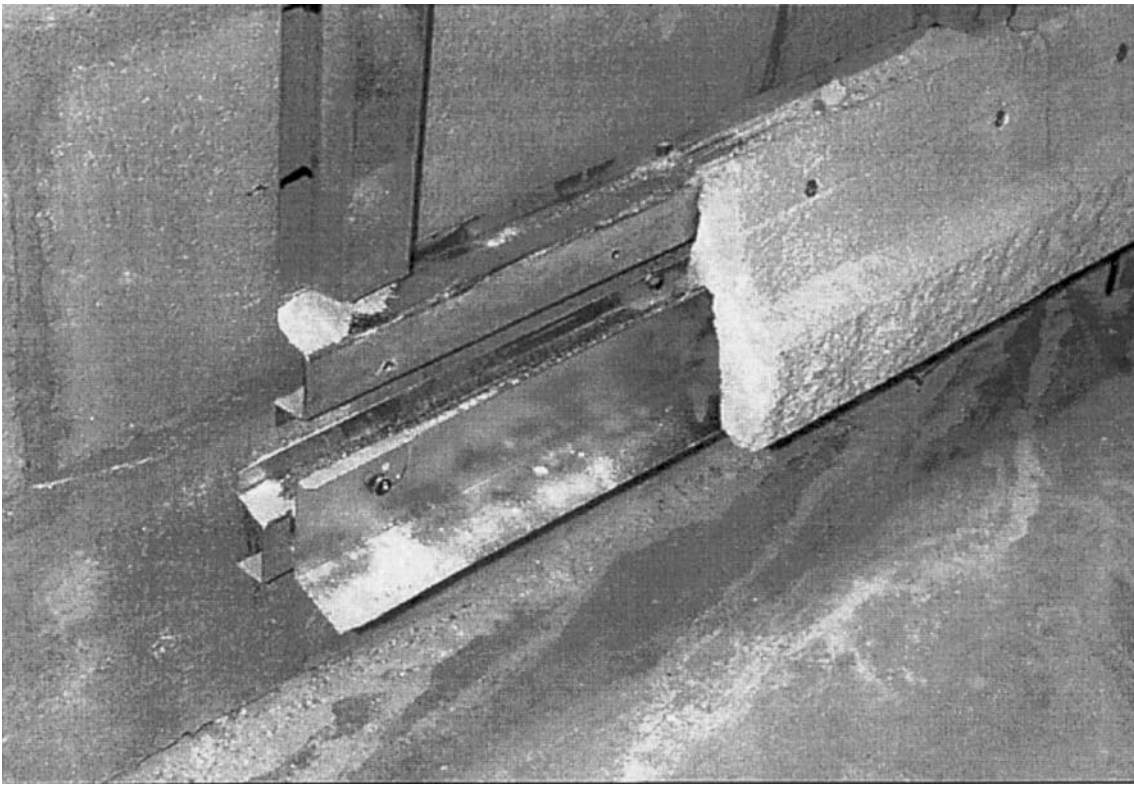
At the bottom course, where all the bricks were fastened with 2 screws, the screws and bricks remained intact after the test. However, the insulation was broken behind the horizontal furrings and the furring-concrete block screws were either bent or broken (see Figure 9). A few had been fastened to the mortar instead of the concrete, which may have weakened the resistance of the furring concrete block device.

Figure B2. Wall base with steel furring : 2 horizontal furrings, 1 vertical furring and the "starter furring"

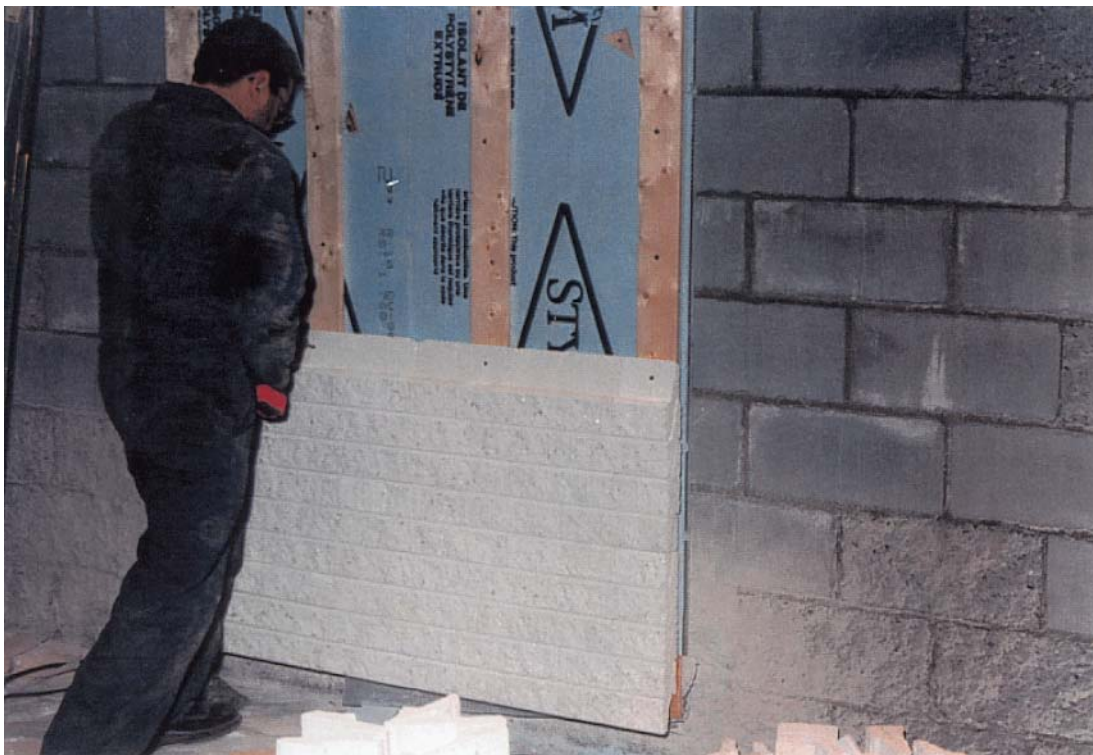
Figure B3. Brick wall with wood furring and the thermal insulation in assembly process

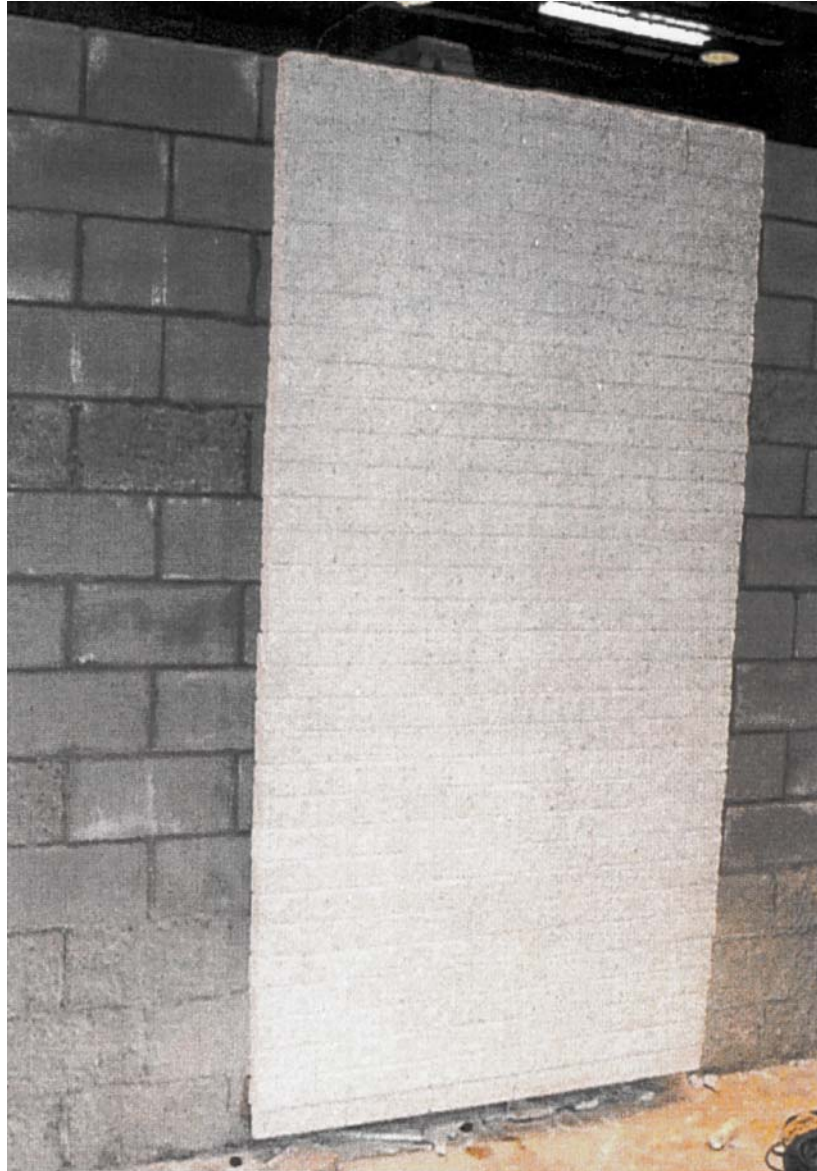
The shear force test on the wall with wooden furrings was stopped at a force of 10,000 pounds after numerous cracking noises caused by screw breakages were heard. A little more than half of the screws fastening the bricks to the furrings were broken. The bricks held by these screws were generally intact. The other screws were bent and the bricks were broken. The materials forming the wall were weakened in shingles (insulation, furring, brick). The displacement of furrings was caused by the enlargement of the screw holes fastening the furrings to the concrete block. However, the screws remained intact. The displacement with a force of 2.5 that of the load capacity was more significant than that obtained for the other wall with metal furrings, however, the wall remained sturdy when the force was maintained for 30 seconds.

Figure B4. Brick wall with wood furrings
