Novabrik fire test report

Object : Acquire authorization for fire preventive wall of a wood frame structure

Wall assembly description: Novabrik / Sheathing Board /
Glasswool insulation / Gypsum Board / Wood Frame Wall

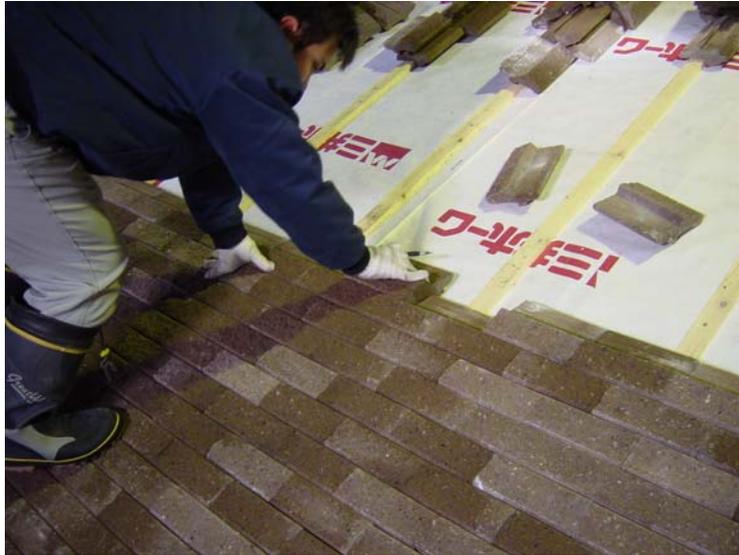
1. Test specimen construction

The test specimen was built at Asahikawa Shinwa Corporation on January 24th, 2005. Novabrik was attached onto the two 30 degree tilted test specimens.

Size : W3,300mm. x H3,250 mm. x 2 specimen

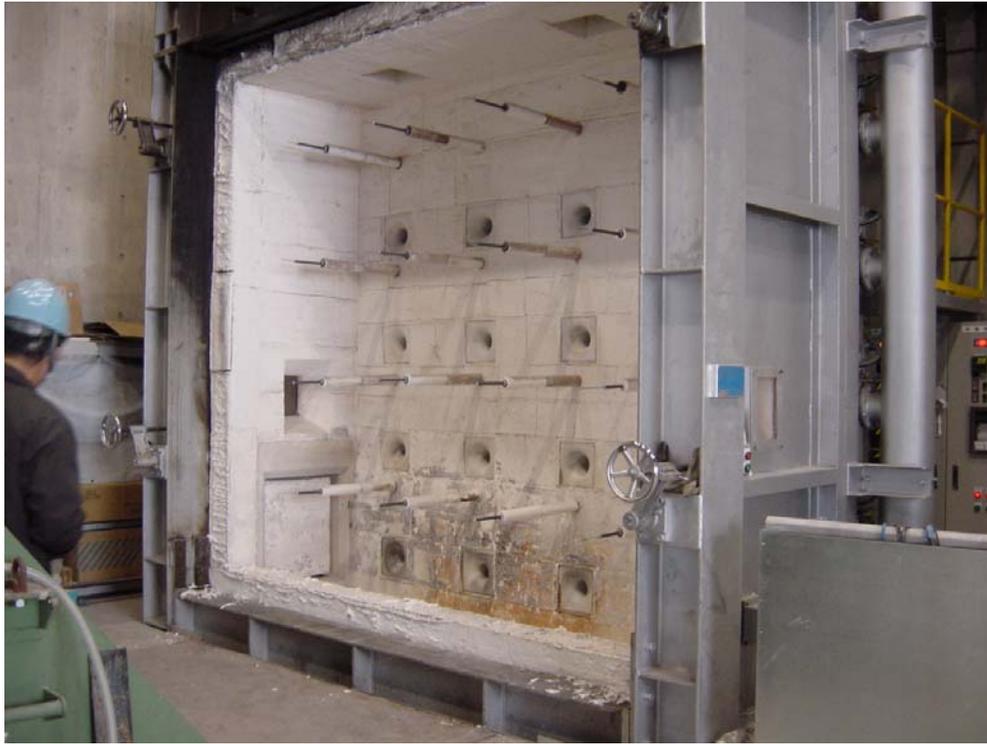
Furnace

Test specimens were connected to a furnace and the exterior of the bricks sides were exposed to heat of up to 800°C. Refer to the files "Fire_Test.xls" and "Fire_Test_Date-1.xls" as to the temperature changes of the exterior and interior sides.

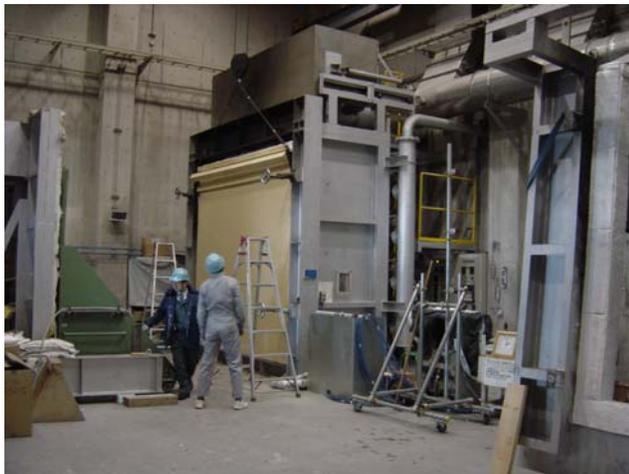
Installation of test specimen

Yonezawa Corporation Inc. Test specimen No.1

Fire-proof construction, exposed to heat for 30 minutes.

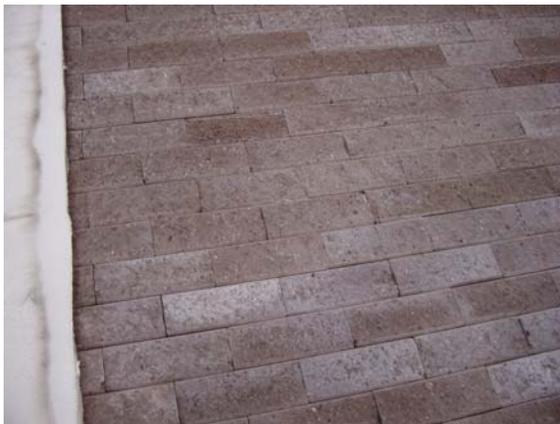
Immediate results of test

During testing, the highest surface temperature of the gypsum board reached 29°C, where the authorized limitation was 180°C.

The only obvious change was the vapour due to moisture coming from inside of the Novabrik. When substrate lumber burns, black smoke comes out.

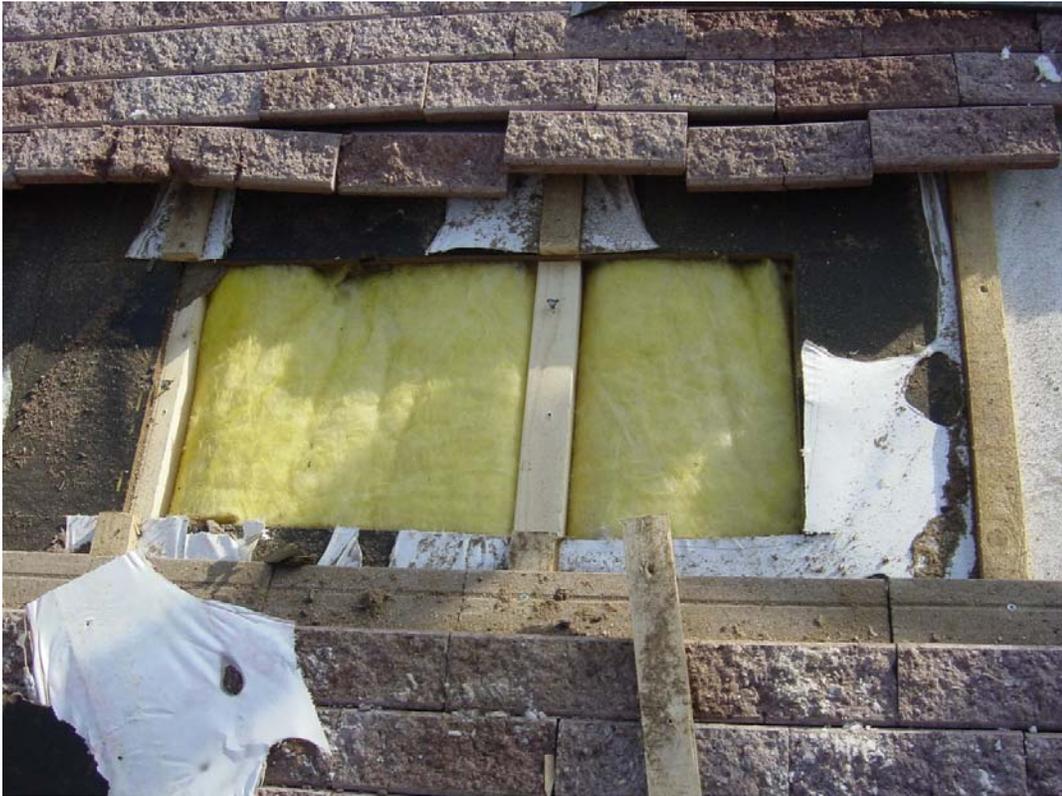
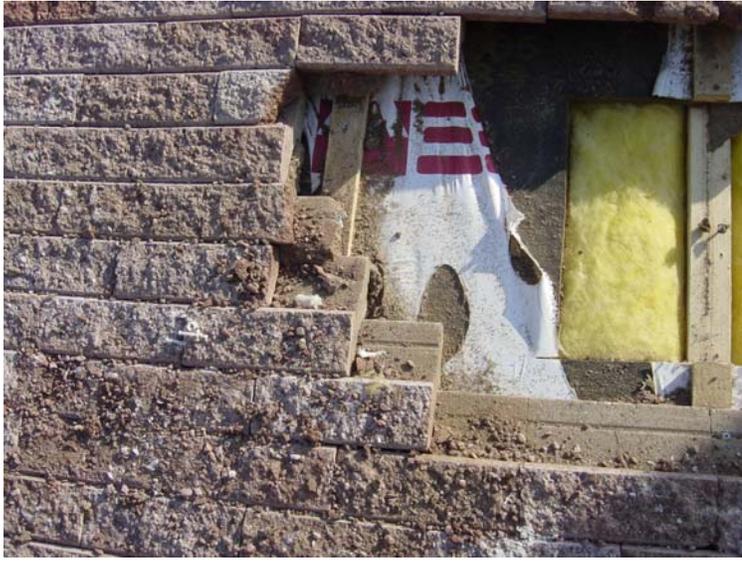
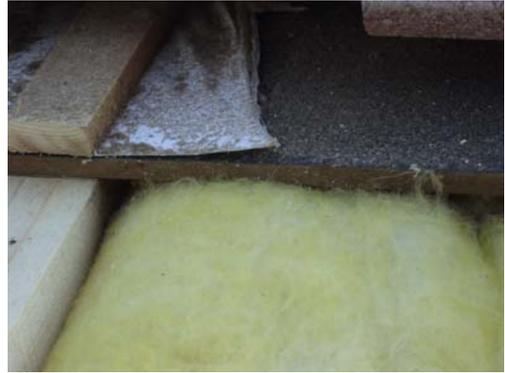
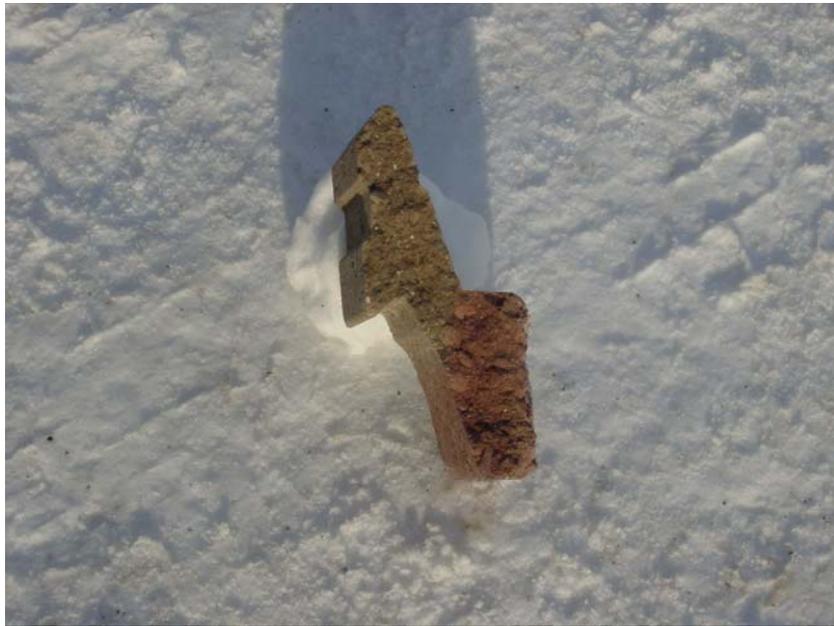
The day following the test, the test specimens were disassembled at Shinwa Corporation. No evidence of combustion was found on the furring strips along with no significant change around the screw holes. The air barrier system (housewrap) melted but it seemed as though the heat spread through the joint. As for the Novabrik, the surface layer changed leaving the other side untouched.

Since the exposed side of the Novabrik was damage, as a result of the test, it would be a necessary precaution to check if the test specimen can withstand the one hour fire test.
